HADITHA GENERAL HOSPITAL
UNDER THE ECONOMIC SUPPORT FUND PROGRAM
HADITHA, IRAQ

SIGIR PA-08-132
JANUARY 23, 2009

SUBJECT: Report on Project Assessment of the Haditha General Hospital, Haditha, Iraq
(SIGIR Report Number PA-08-132)

Haditha General Hospital Under the Economic Support Fund Program Haditha, Iraq

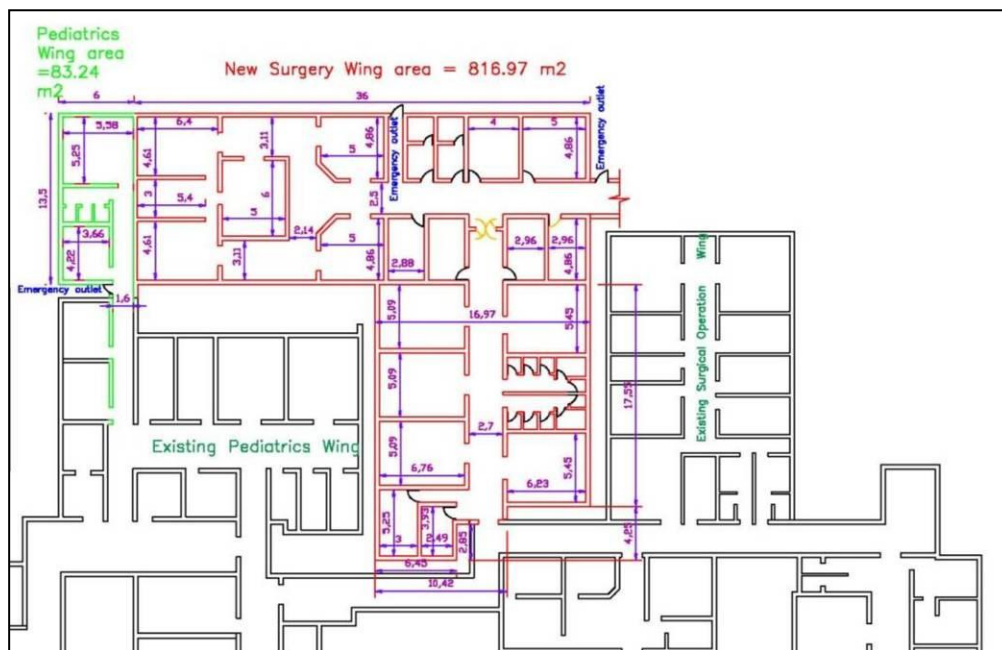
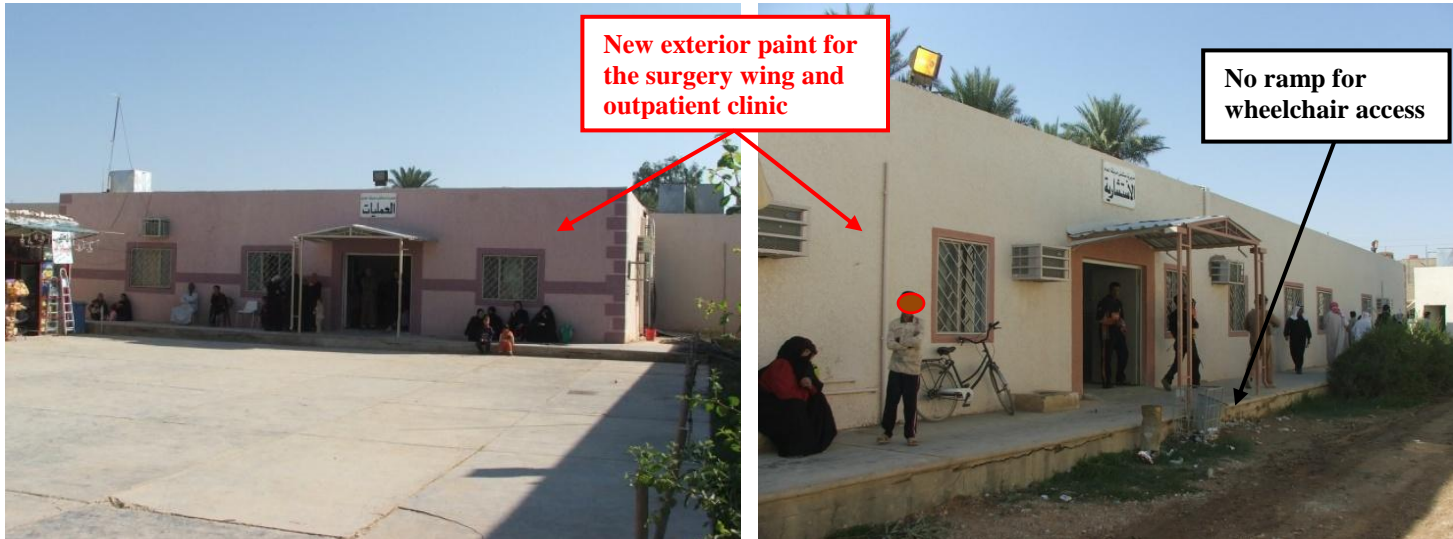
Photos 3 and 4. Exterior of the surgery wing and outpatient clinic buildings

The parking lot had no effective means of channelization or control of internal circulation of traffic. Vehicles were parked in a haphazard manner, which reduced the number of parking spaces available. The parking area was surfaced with dirt and gravel, and had no provisions for surface drainage. Because of the distance from the parking lot to the entrance and the dirt and gravel surface, patients are forced to traverse uneven muddy ground.

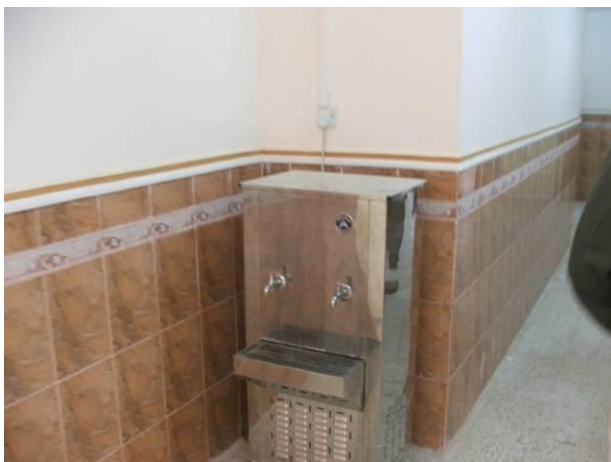
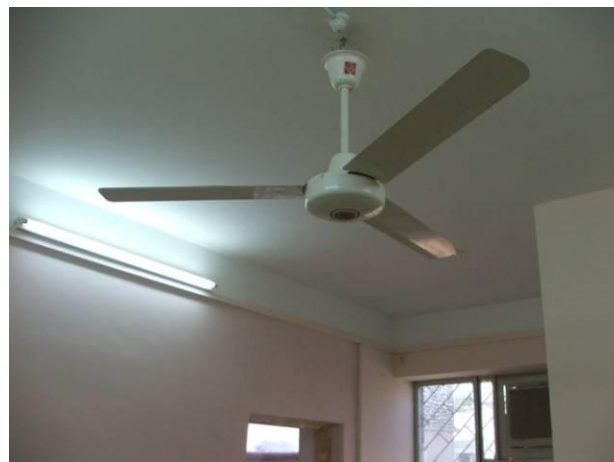
The administrative wing contains the offices for the hospital administration staff. The structure consists of a reinforced concrete frame in-filled with concrete block. In keeping with local practice, all concrete block in the facility is plastered with a cement mortar or gypsum material to create a uniform finish on the exterior and interior of the wall. It appears that most of the renovation work in this area of the hospital has been completed. The walls have been painted and a ceramic tile has been installed in the main corridor to a height of approximately one meter (Site Photo 5). According to the USACE GRC representative, the flooring was in good condition and was not replaced. The renovation of the office included new lighting, ceiling fans, and finishes (Site Photo 6). The contractor representative advised SIGIR that additional renovation was being performed for the administrator's office under a separate contract with the hospital.

Photos 5 and 6. Views of the hospital administration building interior

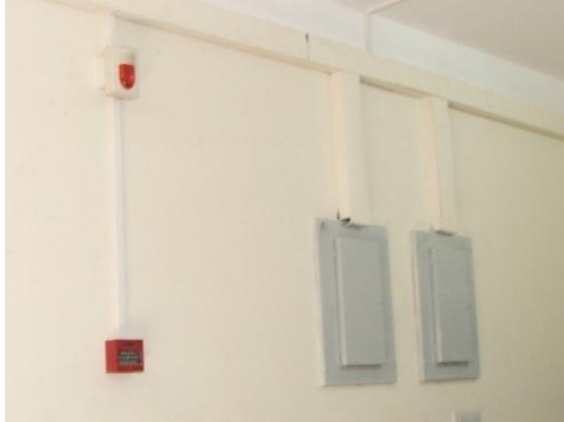
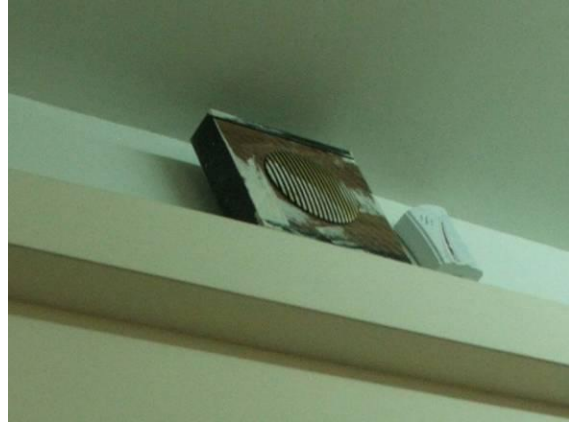
The renovation of the administration wing included an upgrade to the electrical system. SIGIR noted the installation of what appeared to be new wire molding, outlets, light fixtures, and new main distribution panels (MDPs) (Site Photo 7). The MDPs were situated at a reasonable location and were reasonably secure. An intercom system was installed in some areas of the hospital. According to the contractor representative, the system was new; however, due to the careless over-painting of the components, the inspection team could not determine if the equipment was in fact new (Site Photo 8).

Site Photos 7 and 8. Installation of new wire molding, outlets, light fixtures and new main distribution panels (left) and careless over-painting of intercom system (right).

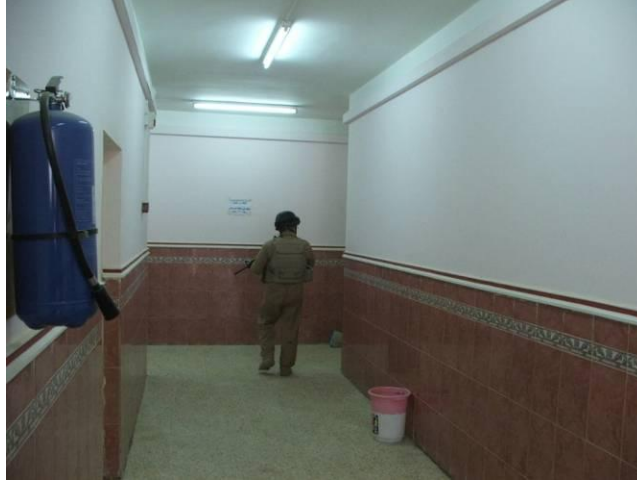
The men's and women's wards appeared to consist of the same type of concrete frame and concrete block infill construction. The main hallways of both wards were renovated with new finishes on the ceiling and walls. The ceiling and walls were painted and ceramic tile installed in the main corridors and most rooms to a height of approximately one meter (Site Photo 9). According to the USACE GRC representative, the flooring was in good condition and was not replaced.

Site Photo 9. Typical ceiling and wall painting and ceramic tile installation.

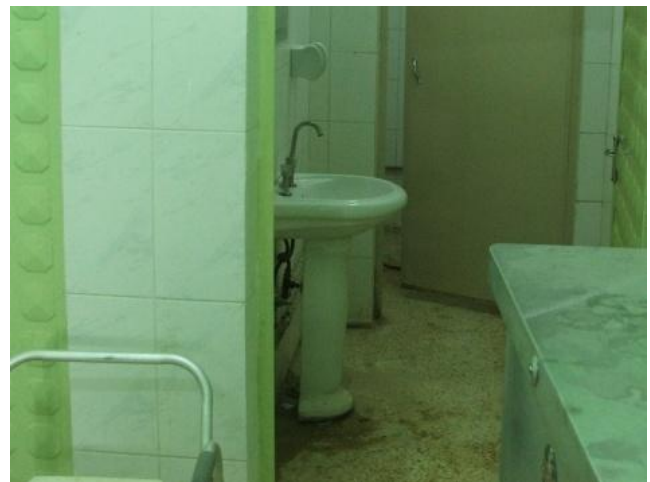
Several of the common restrooms were kept in an unsanitary manner. At least one lavatory in the common restroom between the wards appeared to be leaking and there was standing water on the floor (Site Photo 11). Due to time limitations, SIGIR could not determine if the leak was in a previously renovated area or if the contractor was required to perform additional work, including repair of the lavatory, under the re-scoped portion of the contract. However, there is a significant potential for germs and the spread of disease from the use of the restrooms.

Photos 10 and 11. Heart monitors and defibrillator machines (left) and standing water on the restroom floor (right).

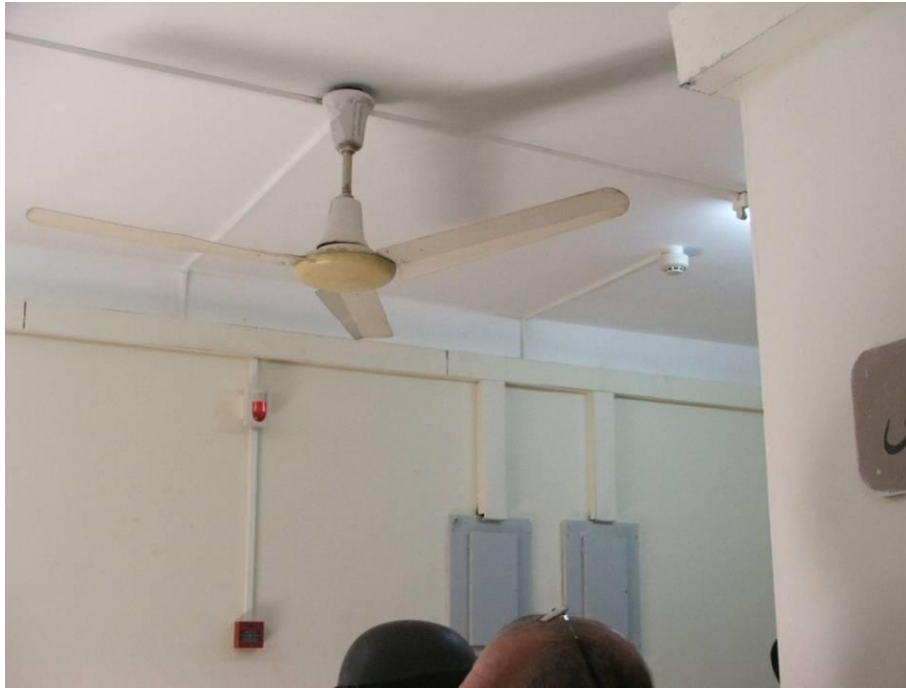
Measures to improve fire safety were included throughout the facility, including in the men's and women's wards and the maternity wing. The contractor installed fire extinguishers, which appeared to be new and fully charged (Site Photo 9). The contractor representative stated a fire alarm system was installed and functioning properly (Site Photo 13).

Site Photo 13. Installation of fire alarm system.

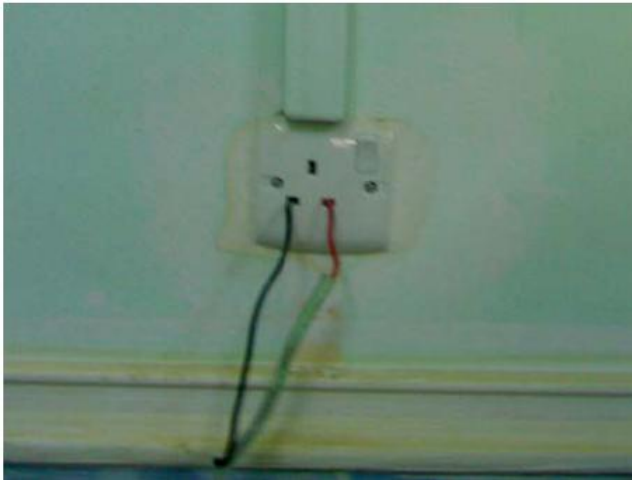
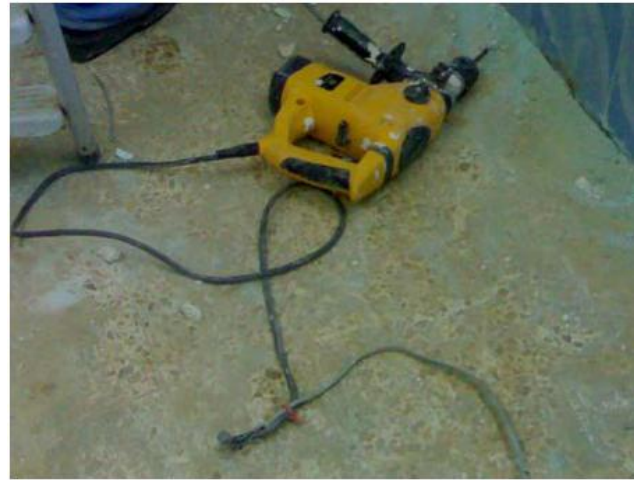
The USACE provided SIGIR with 14 daily QA Representative (QAR) reports from the months of September and October 2008. The reports provided detailed information regarding the progress of renovation and the quality of construction. The QAR provided written reports, including photographs, which documented activities being performed and deficiencies in construction quality or materials. The daily QA reports identified the safety concerns, inferior workmanship, and the progress of construction. For example, the QAR identified potentially dangerous safety concerns with the contractor's use of electrical connections and the corrective actions taken (Site Photos 14-17).

Site Photos 14 and 15. Unsafe electrical practices used by the contractor and captured in daily QA reports (Courtesy of USACE)
